PENTAGON RENOVATION PROGRAM

MARCH 7, 2002

THE PHOENIX PROJECT

- 400,000 square feet
- The outer three rings (E, D, & C)
- Between Corridors 4 & 5
- All 5 floors

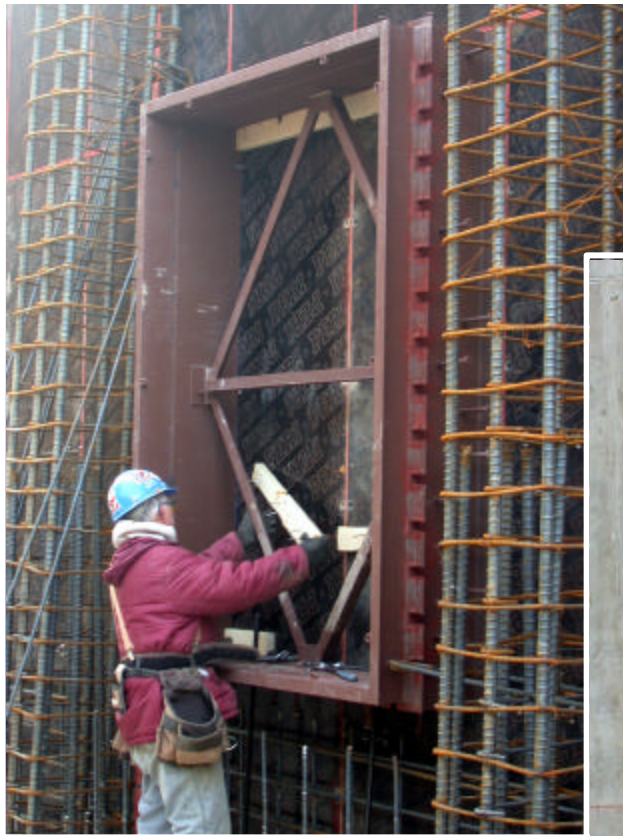
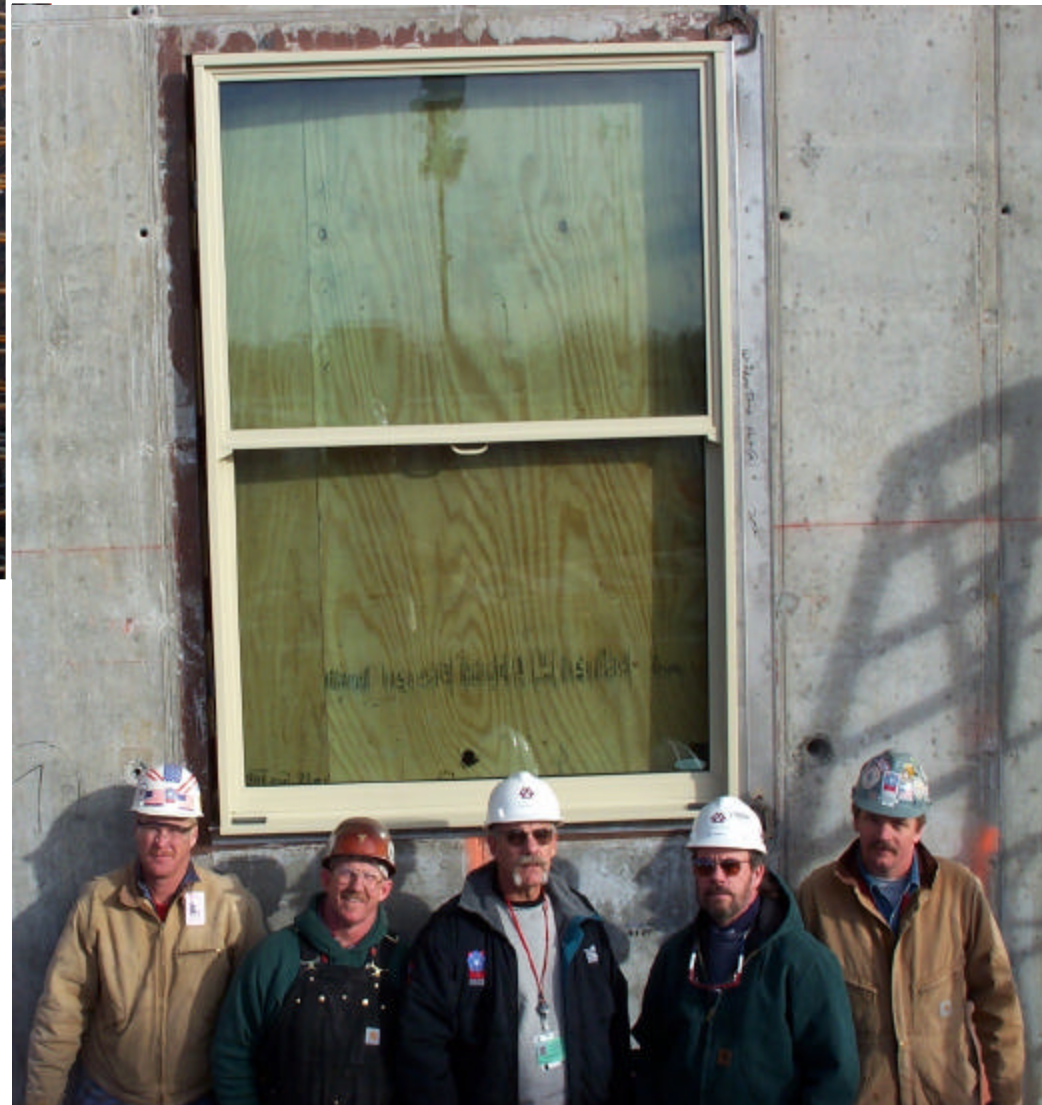
**December 28, 2002:
First E-ring window frame
installed.**

**February 5, 2002:
The first blast
window installed
on the E-ring.**

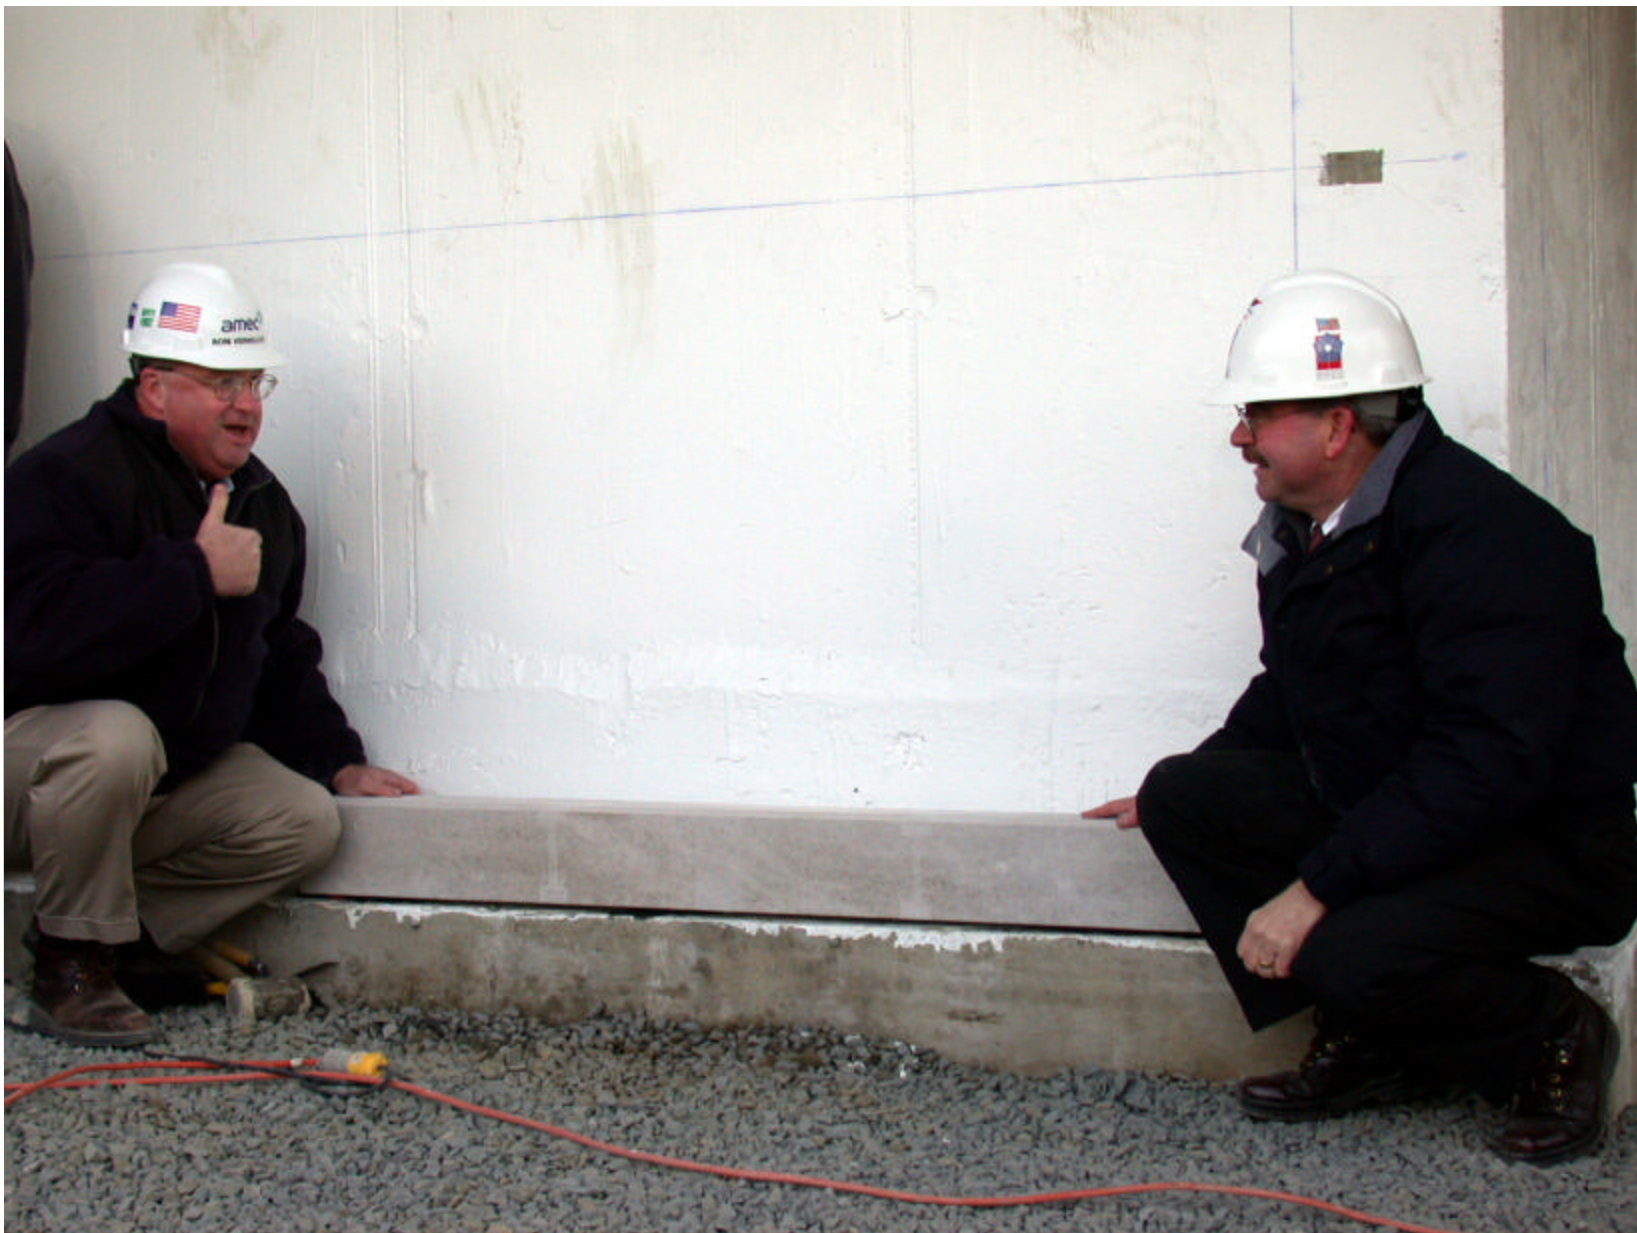
February 25, 2002 – The first piece of limestone is placed on the building exterior

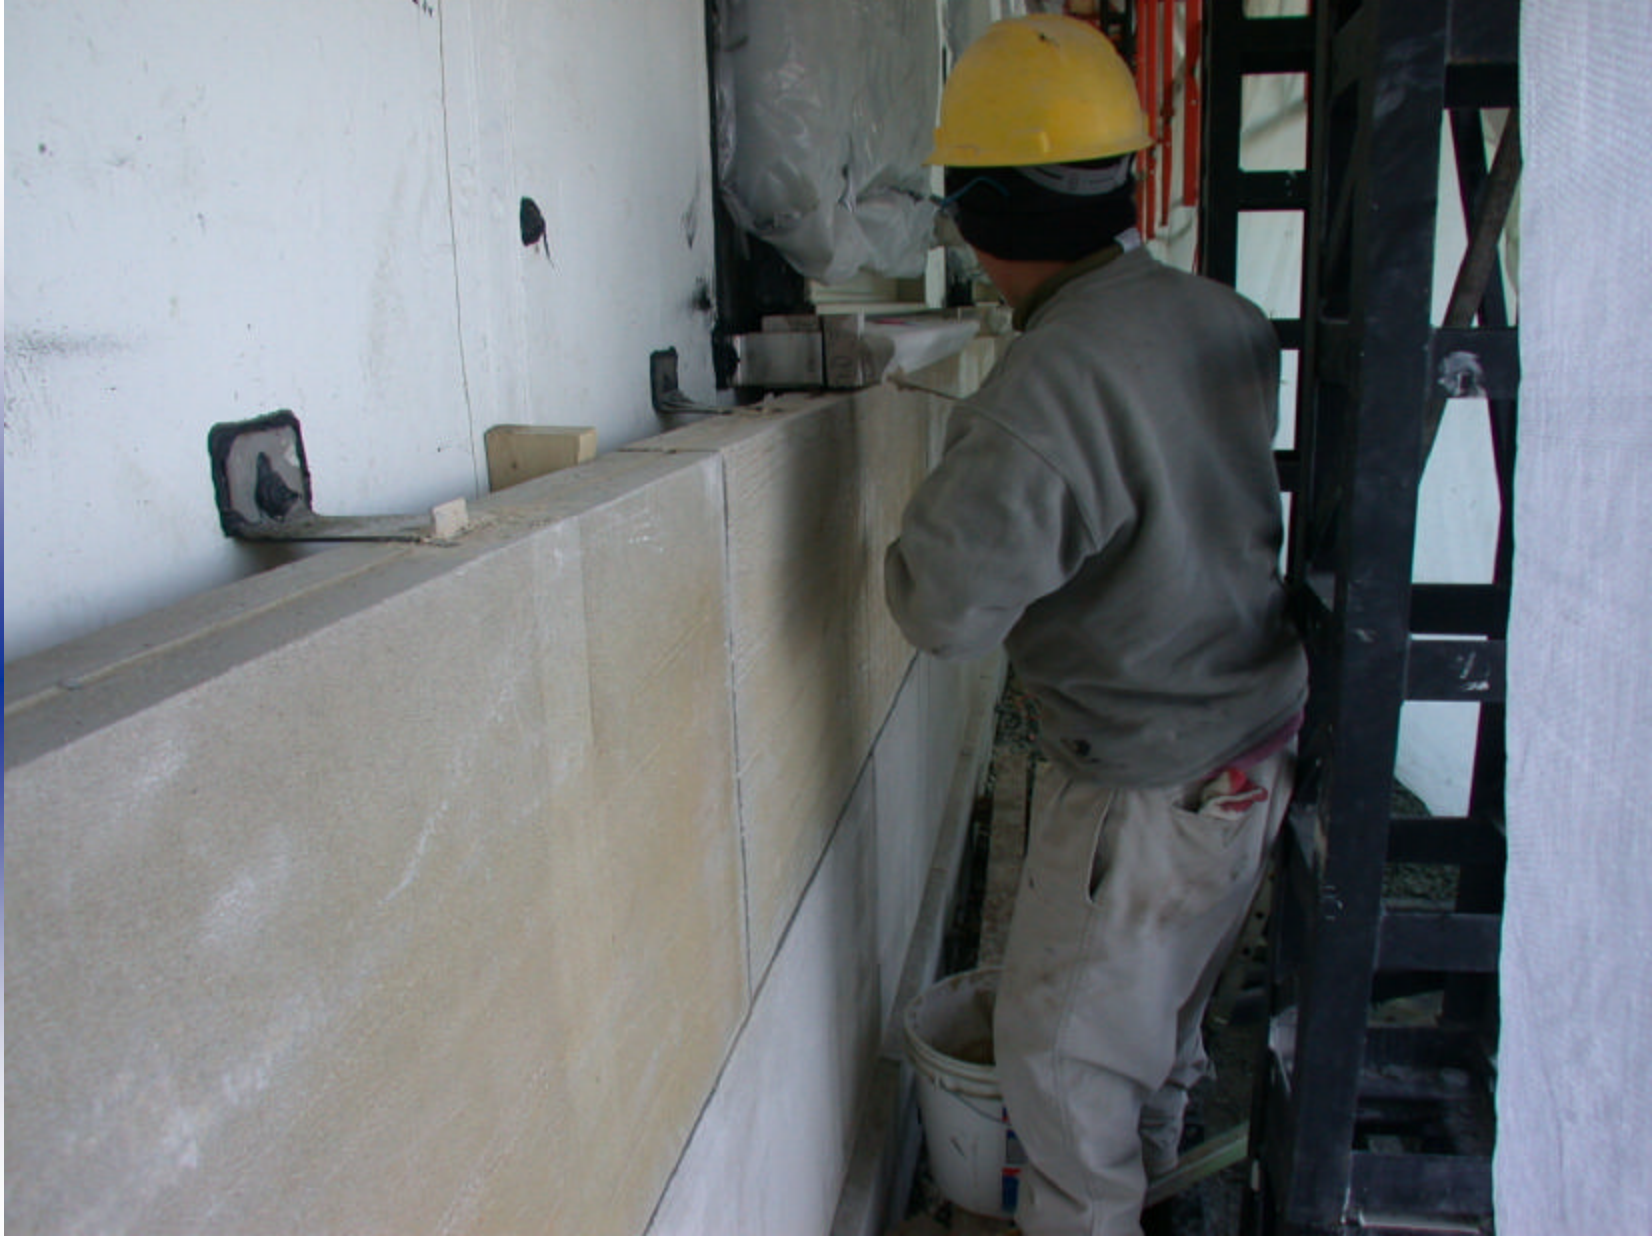
Limestone being hung on the E-Ring facade

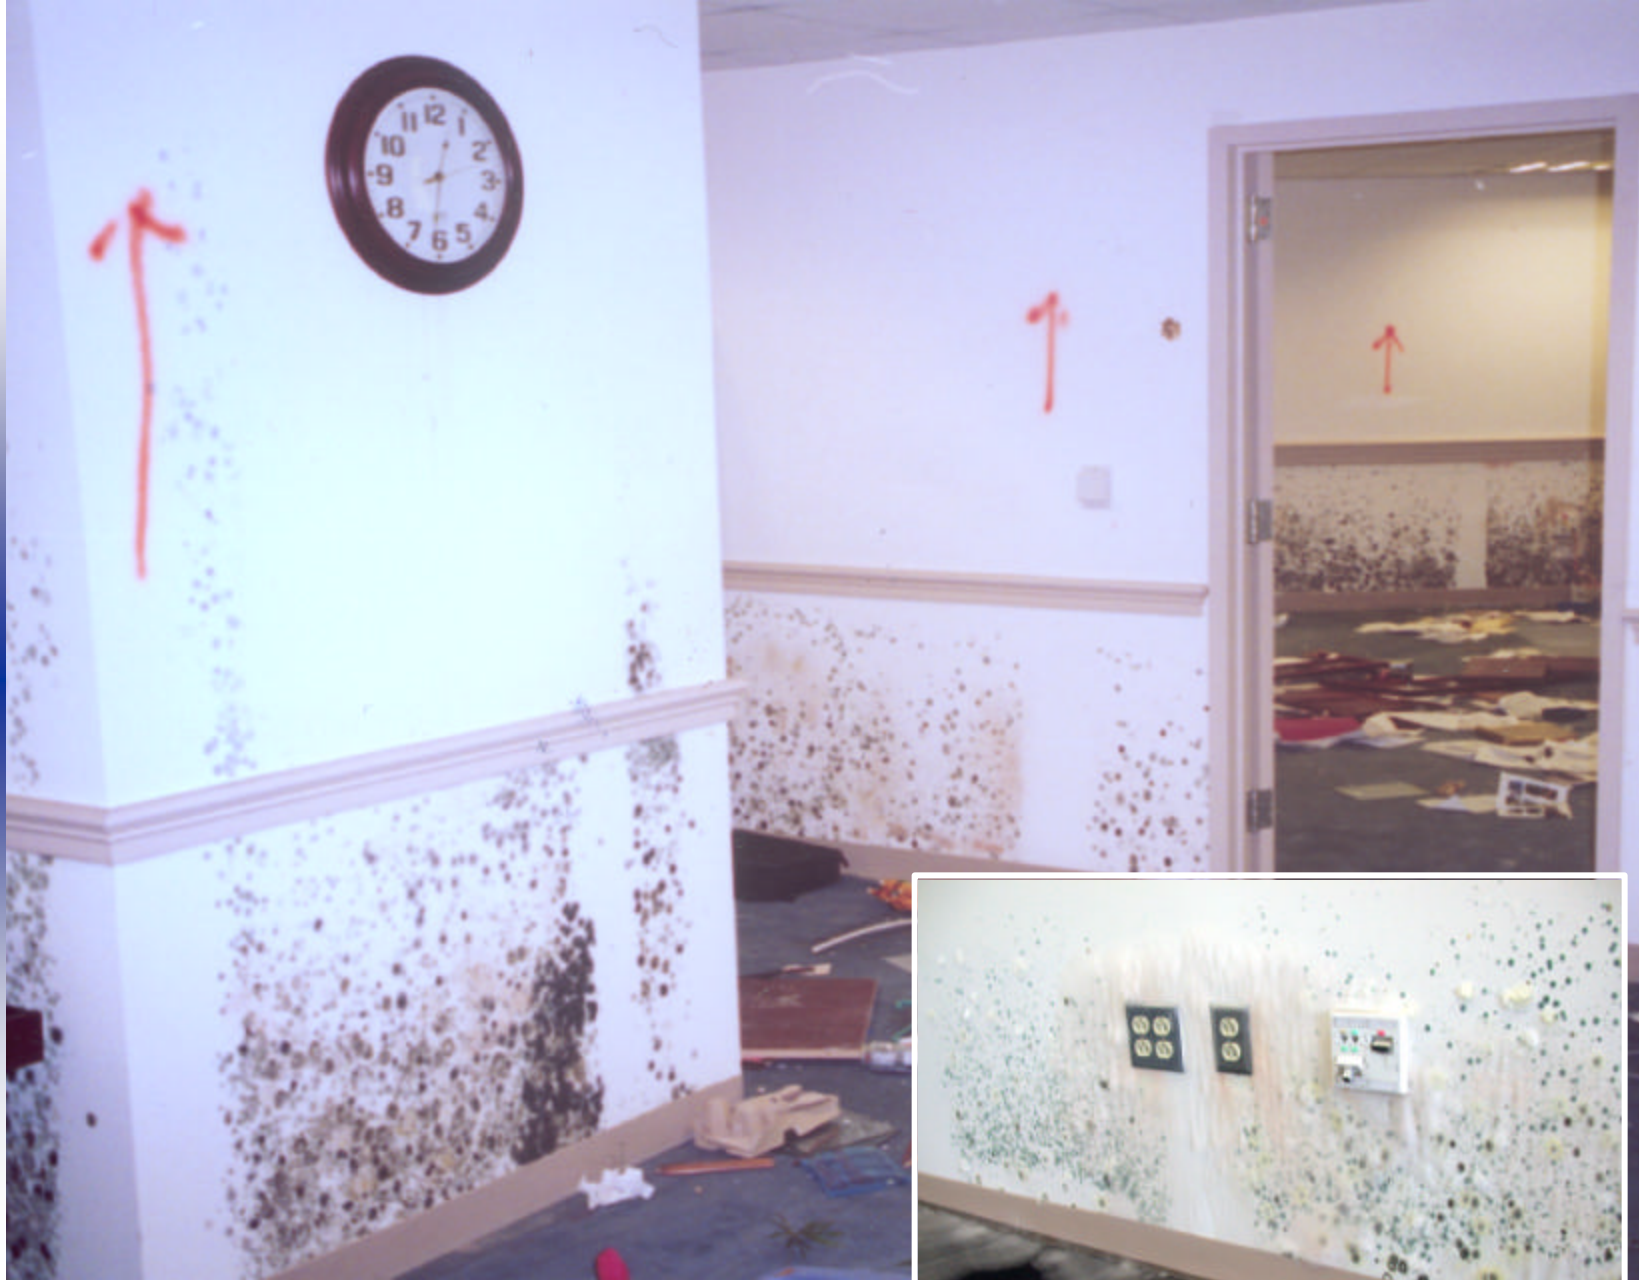
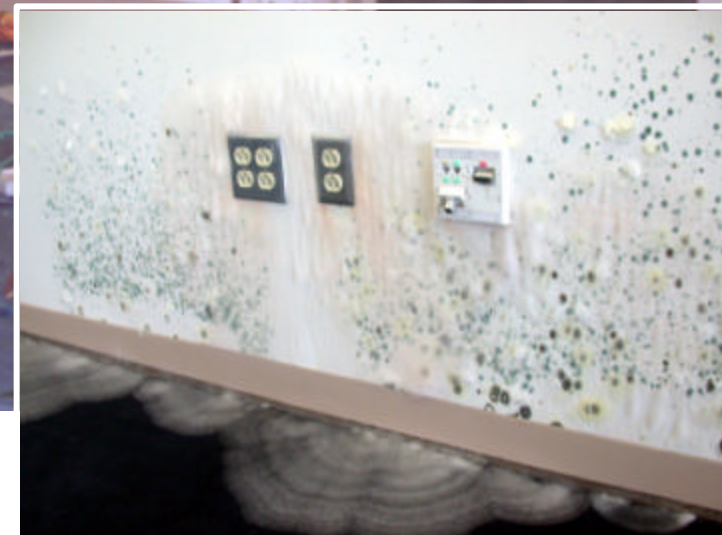
Hazardous mold growth

Mold abatement
